Flood Damage Reduction Segment / System Inspection Report

Name of Segment / System: NPS - Colfax

Public Sponsor(s): Lake County Highway

Corps of Engineers Inspector: USACE Chicago District Inspection Start Date: 2/13/2019

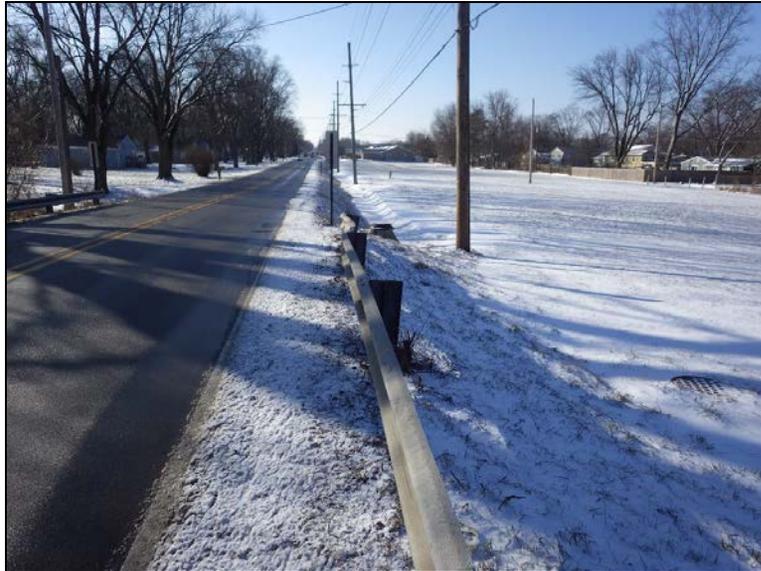
Inspect ID: CMCF_2019_a_0001 **Title:** USACE_CELRC_CMCF_2019_a_0001_1.jpg
Rated Item: 3. Encroachments **Caption:** Rating: Minimally Acceptable; Remarks: Guardrail on top of landside slope.; Action: Relocate.

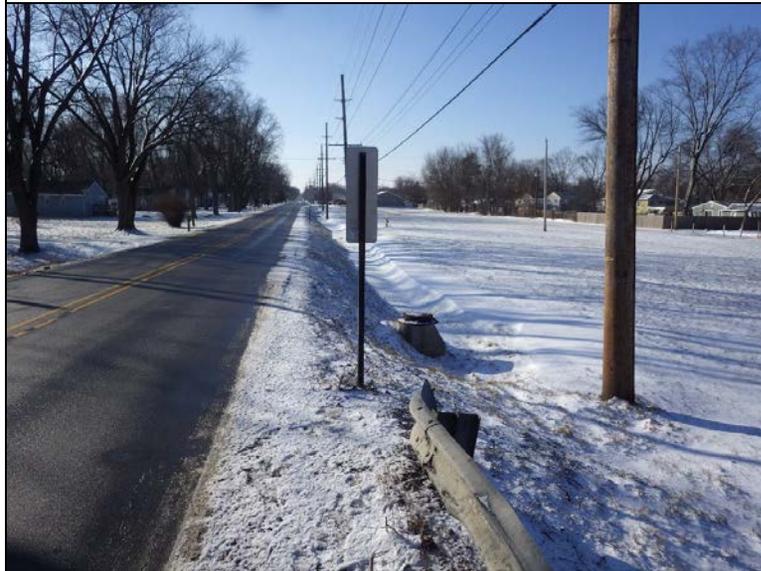
Inspect ID: CMCF_2019_a_0002 **Title:** USACE_CELRC_CMCF_2019_a_0002_1.jpg
Rated Item: 3. Encroachments **Caption:** Rating: Acceptable; Remarks: Small sign on top of landside slope.; Action: No action.

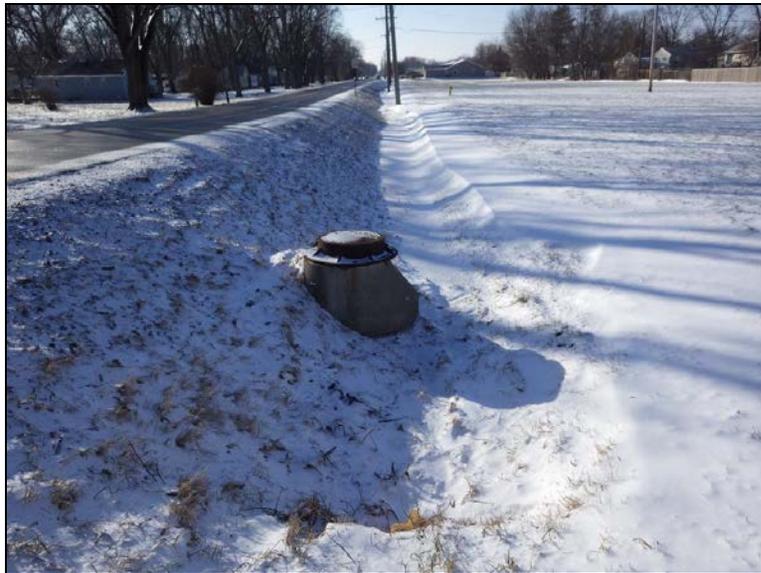
Inspect ID: CMCF_2019_a_0003 **Title:** USACE_CELRC_CMCF_2019_a_0003_1.jpg
Rated Item: 3. Encroachments **Caption:** Rating: Acceptable; Remarks: Manhole in ditch.; Action: Monitor for seepage.

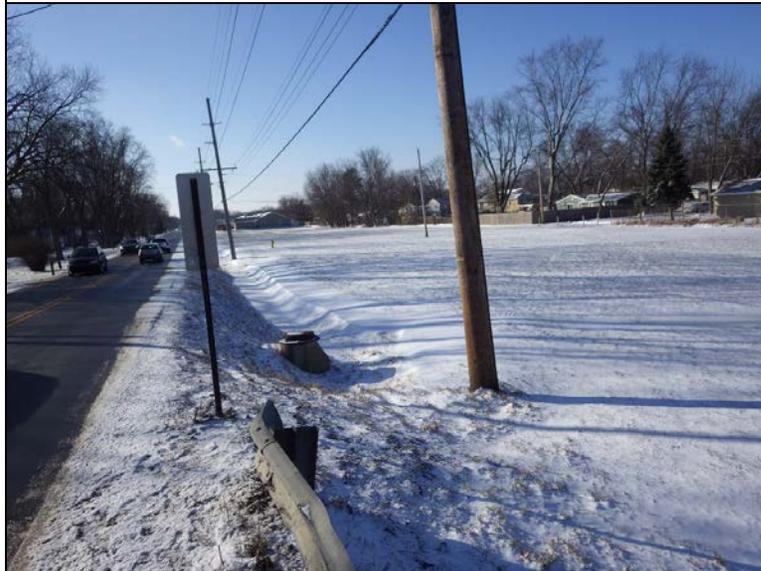
Inspect ID: CMCF_2019_a_0004 **Title:** USACE_CELRC_CMCF_2019_a_0004_1.jpg
Rated Item: 3. Encroachments **Caption:** Rating: Minimally Acceptable; Remarks: Power pole 4 ft from landside toe.; Action: Provide as-builts.

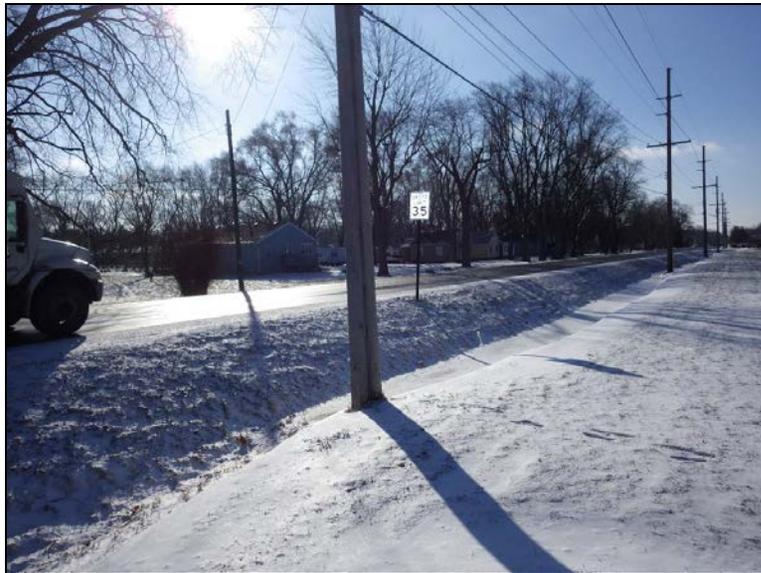
Inspect ID: CMCF_2019_a_0005 **Title:** USACE_CELRC_CMCF_2019_a_0005_1.jpg
Rated Item: 3. Encroachments **Caption:** Rating: Minimally Acceptable; Remarks: Power pole on landside.; Action: Provide as-builts.

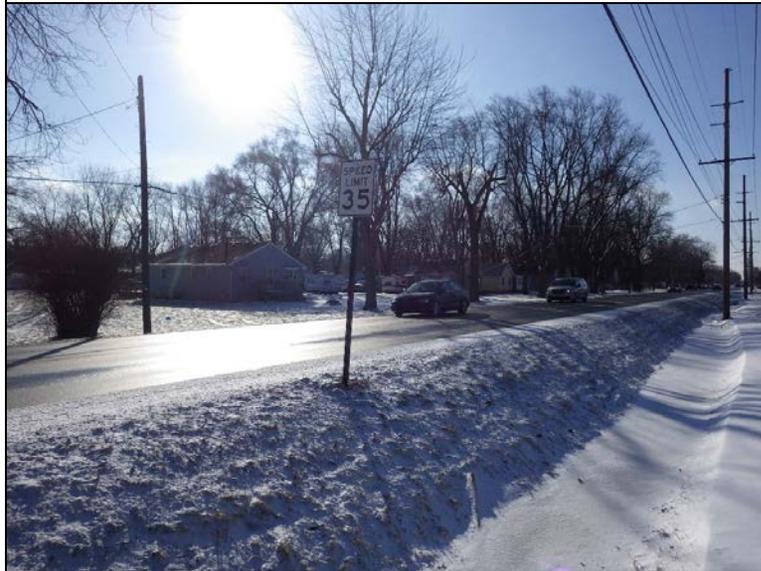
Inspect ID: CMCF_2019_a_0006 **Title:** USACE_CELRC_CMCF_2019_a_0006_1.jpg
Rated Item: 3. Encroachments **Caption:** Rating: Acceptable; Remarks: Small sign on top of landside slope.; Action: No action.

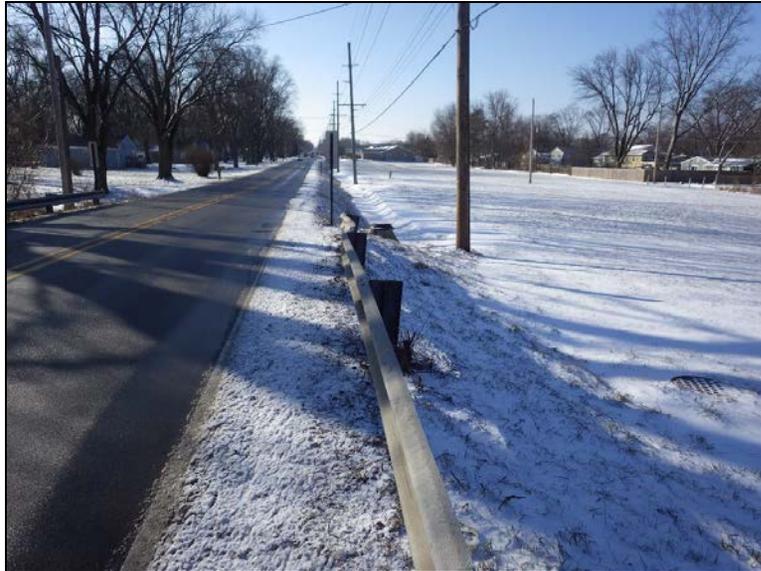
Inspect ID: CMCF_2019_a_0007 **Title:** USACE_CELRC_CMCF_2019_a_0007_1.jpg
Rated Item: 3. Encroachments **Caption:** Rating: Minimally Acceptable; Remarks: Manhole on landside toe.; Action: Relocate.
