Flood Damage Reduction Segment / System Inspection Report

Name of Segment / System: NPS - Cady Marsh RR Tieback

Corps of Engineers Inspector: USACE Chicago District Inspection Start Date: 2/13/2019

Flood Damage Reduction Segment / System
Inspection Report
NPS - Cady Marsh RR Tieback (CMRR)

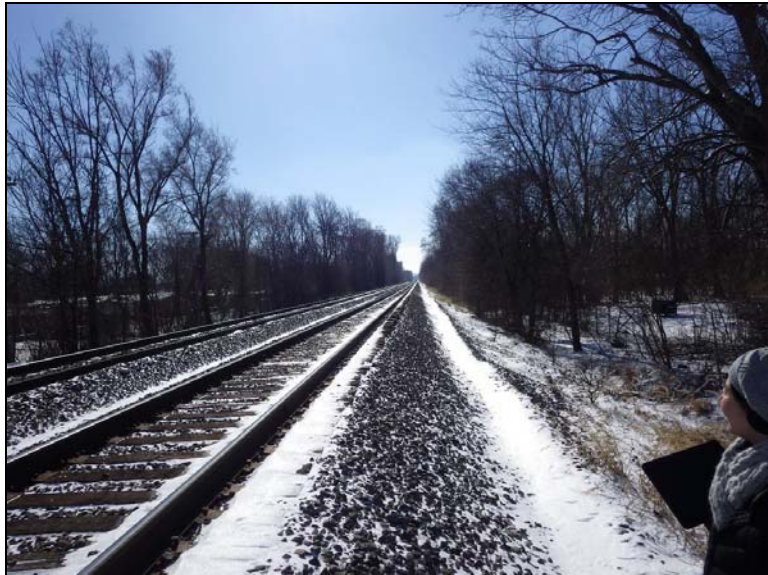
Inspect ID: CMRR_2019_a_0001 **Title:** USACE_CELRC_CMRR_2019_a_0001_1.jpg
Rated Item: 1. Unwanted Vegetation Growth **Caption:** Rating: Minimally Acceptable;
Remarks: Trees along the landside toe of the railroad embankment.; **Action:** Remove trees within the vegetation free zone (15 ft from the toe).

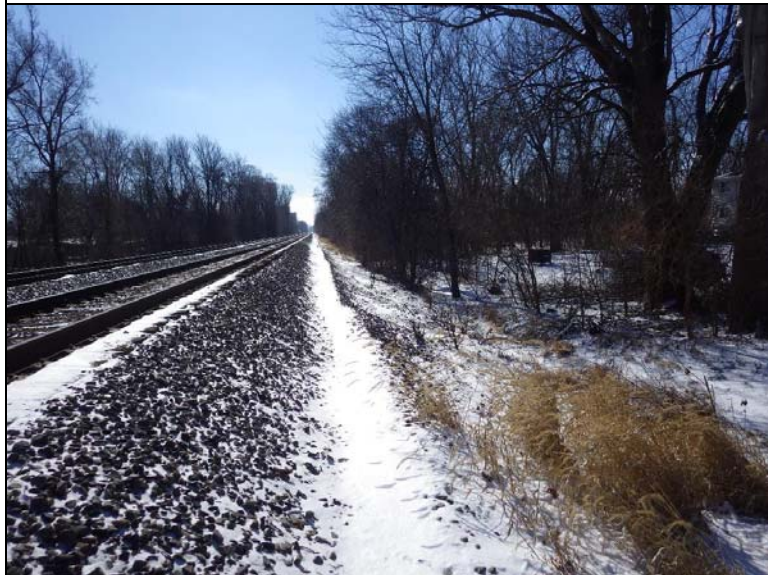
Inspect ID: CMRR_2019_a_0002 **Title:** USACE_CELRC_CMRR_2019_a_0002_1.jpg
Rated Item: 1. Unwanted Vegetation Growth **Caption:** Rating: Minimally Acceptable;
Remarks: Trees along the riverside toe of the railroad embankment.; **Action:** Remove trees within the vegetation free zone (15 ft from the toe).
