Flood Damage Reduction Segment / System Inspection Report

Name of Segment / System: Cady Marsh - South

Flood Damage Reduction Segment / System
Inspection Report
Cady Marsh - South (CMDS)

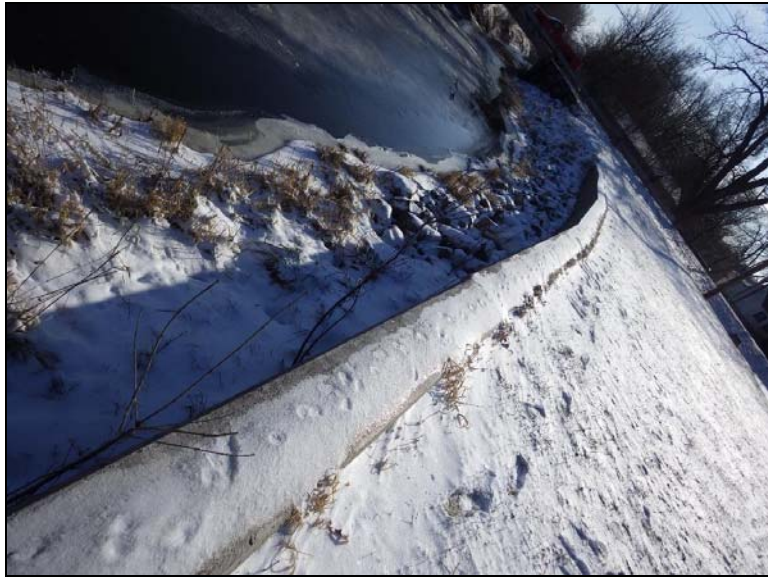
Inspect ID: CMDS_2019_a_0001 **Title:** USACE_CELRC_CMDS_2019_a_0001_1.jpg
Rated Item: 1. Unwanted Vegetation Growth **Caption:** Rating: Minimally Acceptable;
Remarks: Small trees on riverside of floodwall.; **Action:** Cut.

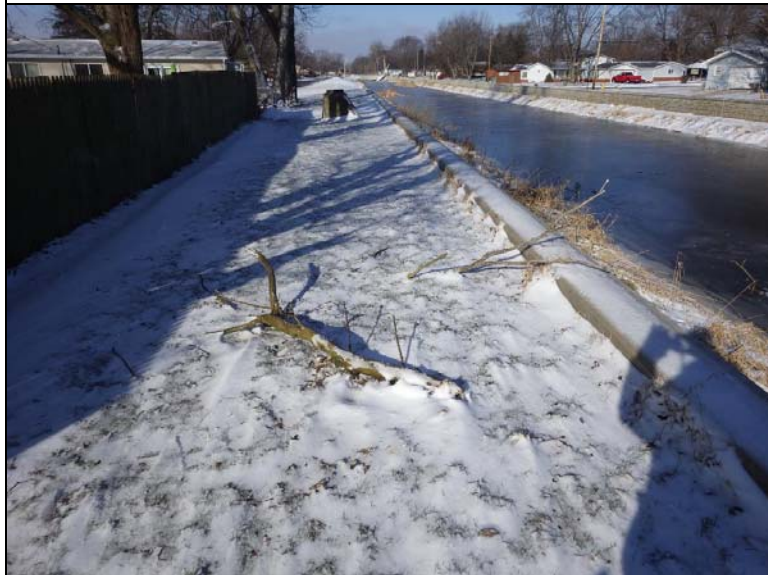
Inspect ID: CMDS_2019_a_0002 **Title:** USACE_CELRC_CMDS_2019_a_0002_1.jpg
Rated Item: 2. Encroachments **Caption:** Rating: Minimally Acceptable; **Remarks:**
Branch on top of wall.; **Action:** Remove.

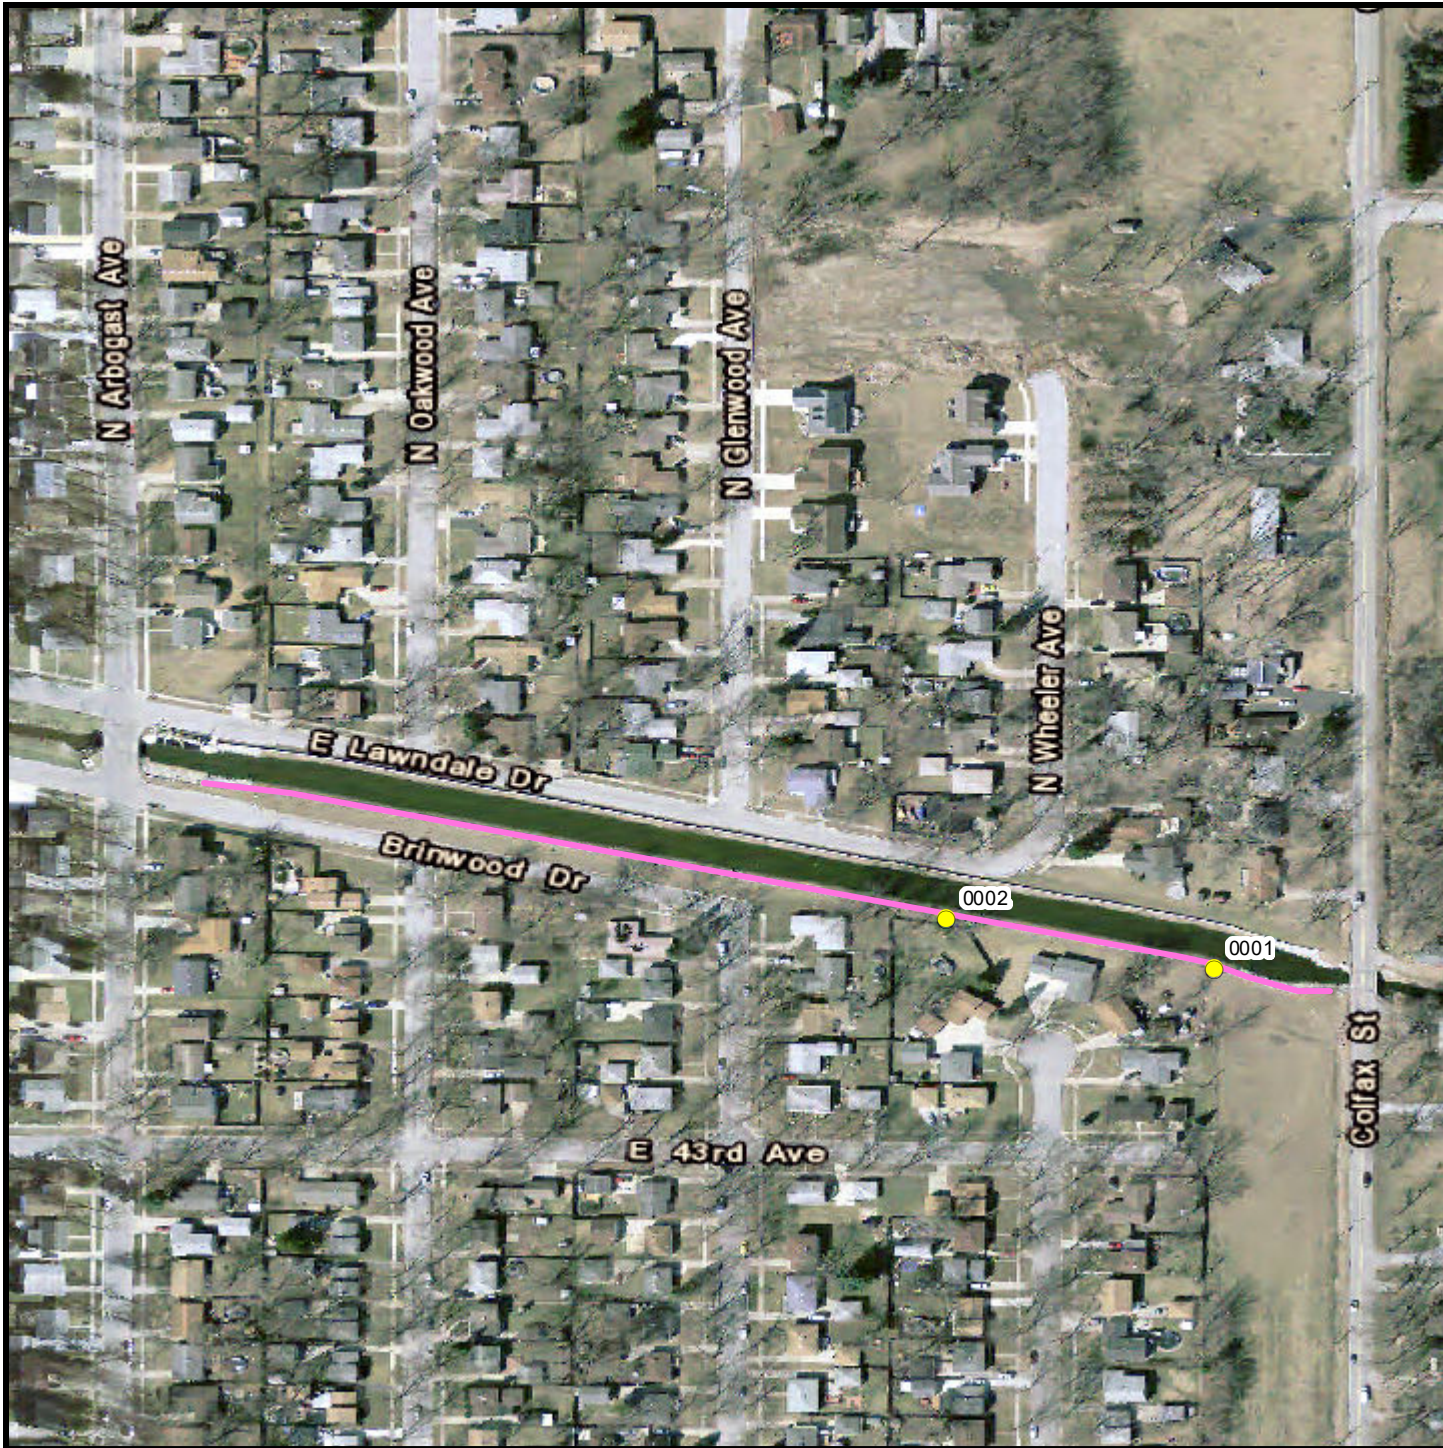
Levee Inspection Map

Location: Griffith, IN
 Year/cycle: 2019 a
 Inspection type: Routine
 Inspected by: USACE Chicago District
 Inspection date(s): February 13, 2019
 Observation ID prefix:
 USACE_CELRC_CMD5_2019_a
 Map created: 04 March 2019
