Flood Damage Reduction Segment / System Inspection Report

Name of Segment / System: NPS - Colfax

Public Sponsor(s): Lake County Highway

Corps of Engineers Inspector: USACE Chicago District Inspection Start Date: 2/13/2019

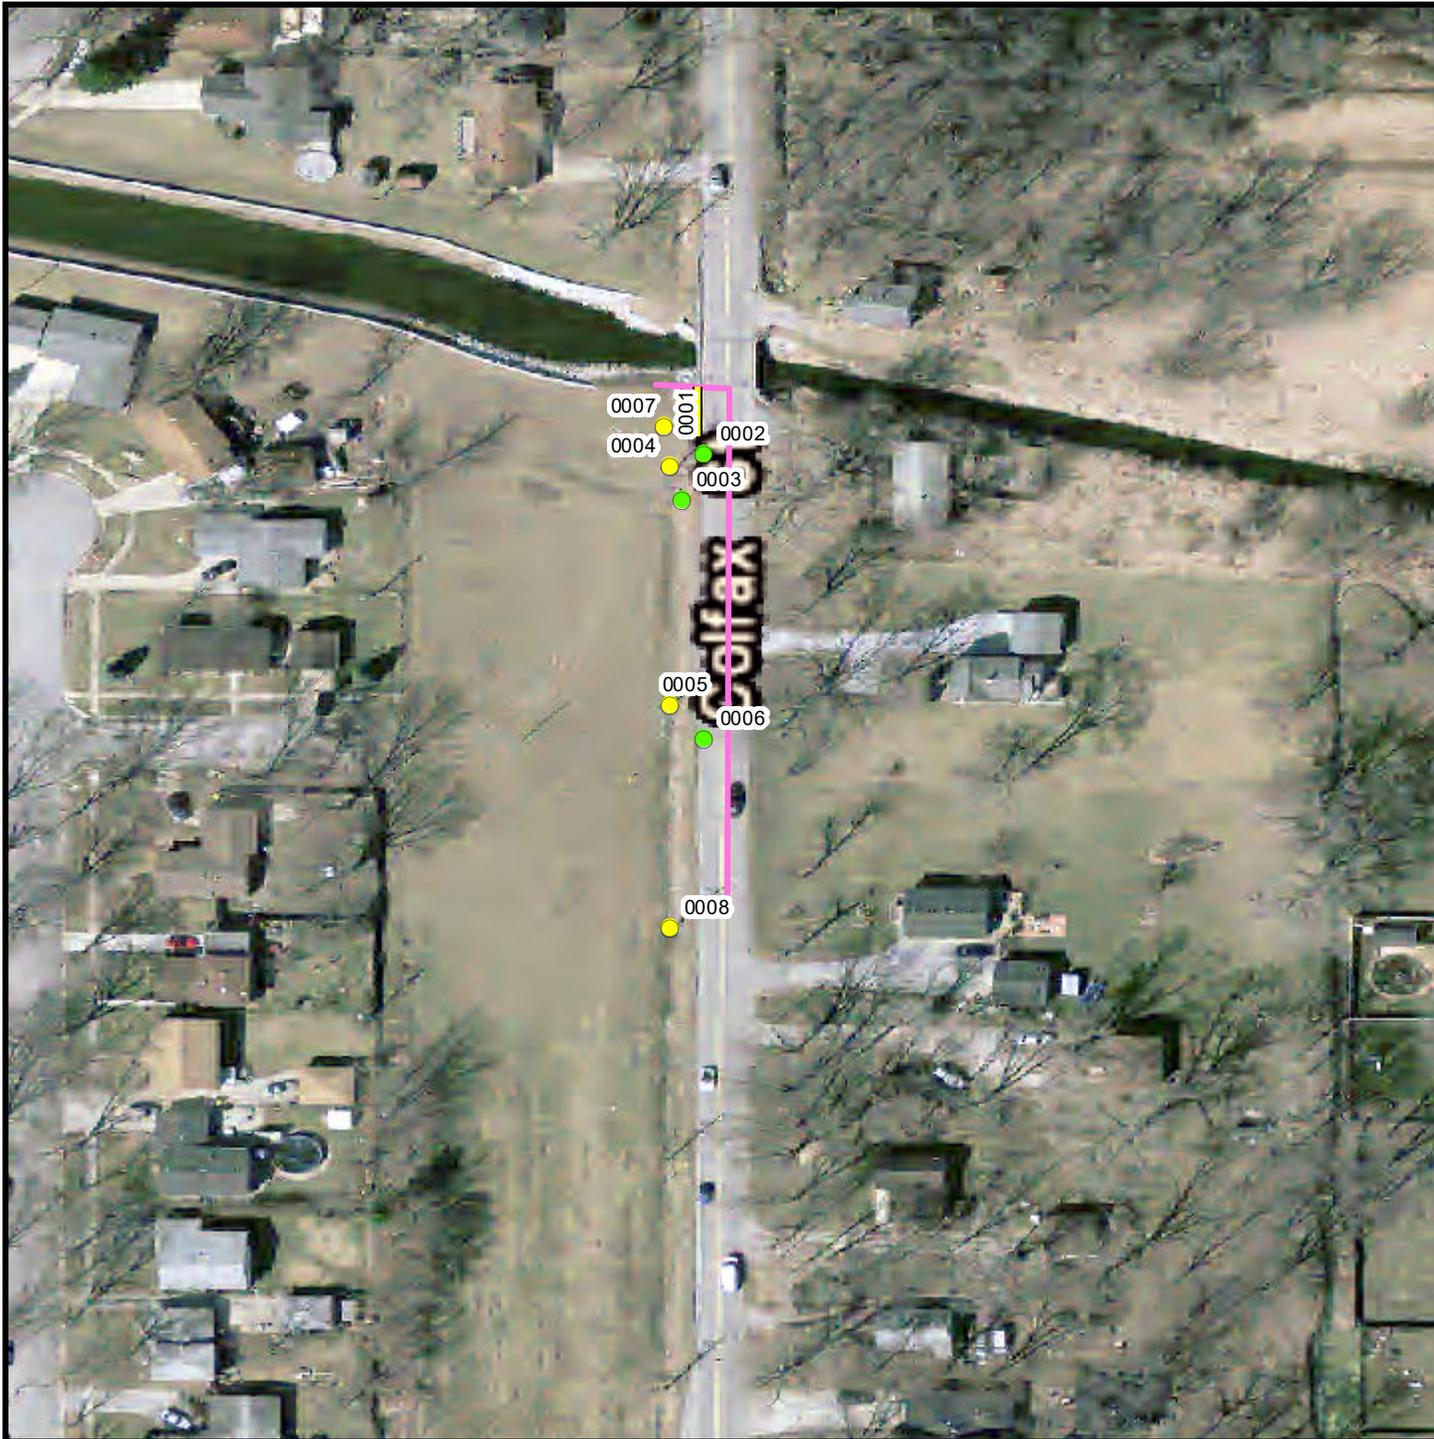
Inspect ID: CMCF_2019_a_0007 **Title:** USACE_CELRC_CMCF_2019_a_0007_1.jpg
Rated Item: 3. Encroachments **Caption:** Rating: Minimally Acceptable; Remarks: Manhole on landside toe.; Action: Relocate.
