Flood Damage Reduction Segment / System Inspection Report

Name of Segment / System: NPS - Cady Marsh RR Tieback

Corps of Engineers Inspector: USACE Chicago District Inspection Start Date: 2/13/2019

Flood Damage Reduction Segment / System
Inspection Report
NPS - Cady Marsh RR Tieback (CMRR)

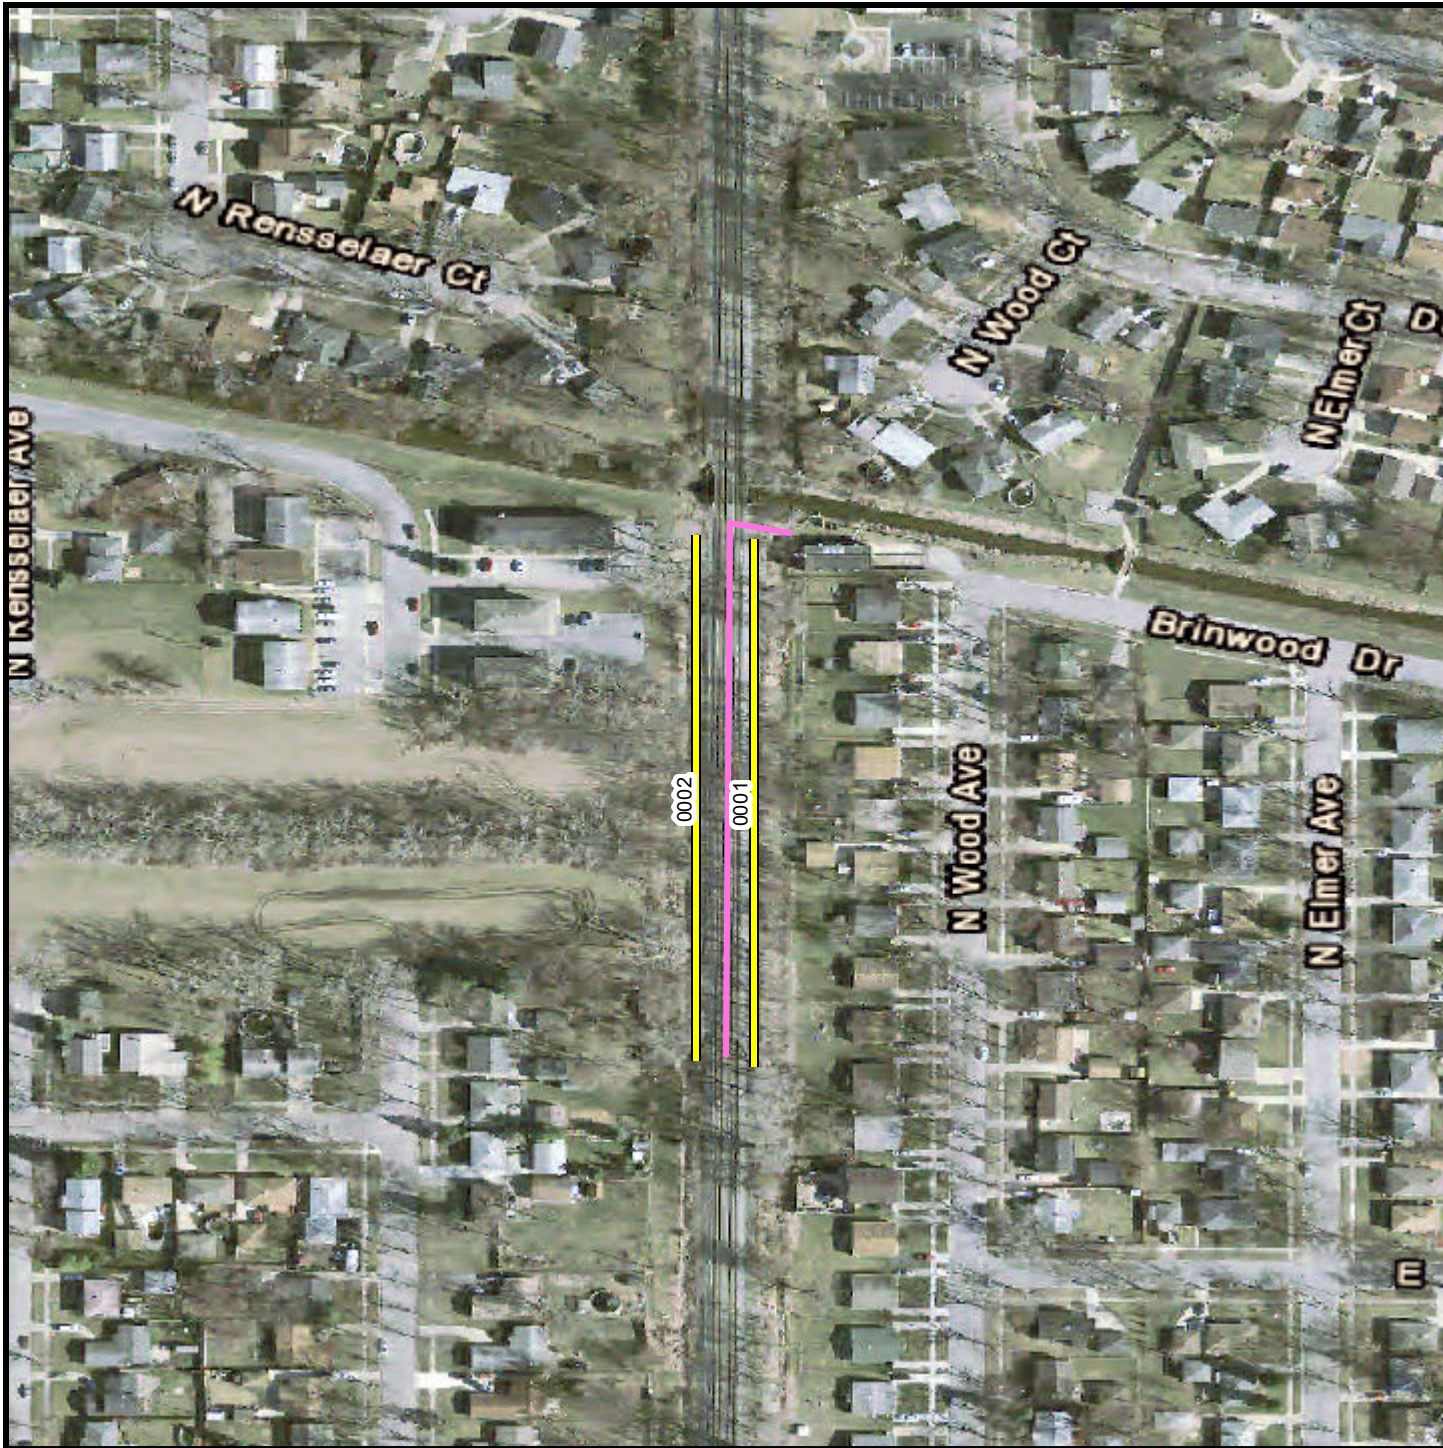
Inspect ID: CMRR_2019_a_0002 **Title:** USACE_CELRC_CMRR_2019_a_0002_1.jpg
Rated Item: 1. Unwanted Vegetation Growth **Caption:** Rating: Minimally Acceptable;
Remarks: Trees along the riverside toe of the railroad embankment.; **Action:** Remove trees within the vegetation free zone (15 ft from the toe).
